**Lawrence Radiation Laboratory**  
UNIVERSITY OF CALIFORNIA  
LIVERMORE

UCRL-50465

**STERLING REENTRY**

The Sterling Event was a 380-ton nuclear detonation conducted in the cavity remaining from the Salmon Event at a depth of 2717 ft in the Tatum salt dome near Hattiesburg, Miss.

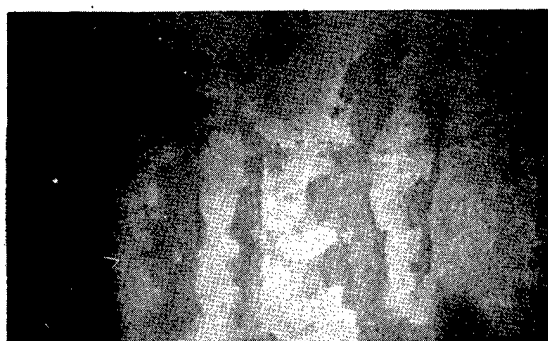
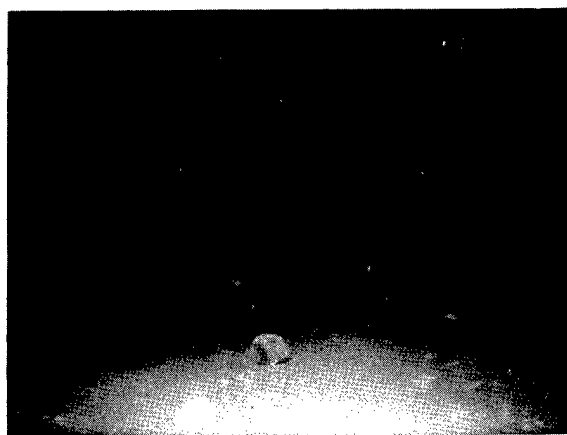
The enlarged 35mm photos shown in Figs. 10 through 12 were dark, but the roof and floor areas were visible. There were no collapsed areas distinguishable in the roof. The floor was dry and the rubble pile appeared to cover about the center one-third of the diameter of the floor.

Fig. 10. Cavity roof at approximate depth of 2665 ft.

Fig. 11. Cavity side wall at approximate depth of 2720 ft.

Fig. 12. Cavity floor showing rubble pile and wall-to-floor transition.
